# “Swiss Association of Aeronautical Science”

*It is a Complex Business this Aircraft Structural Integrity...*

*L. Molent AM*

# Significant Ways Aircraft Fail Operationally

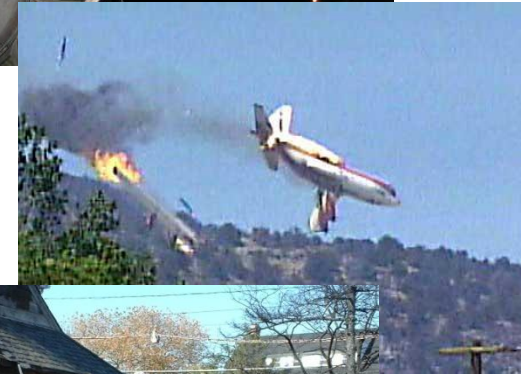
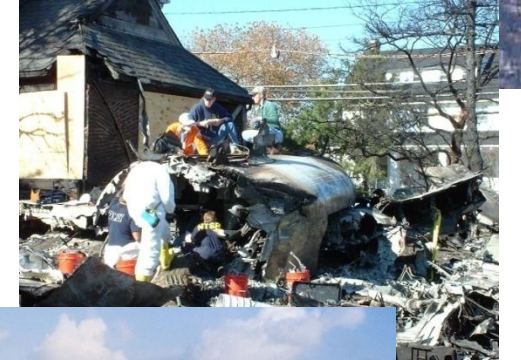
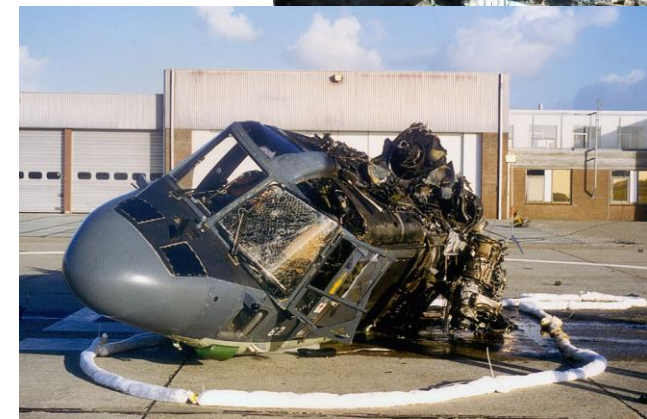
# UPS MD-11F 4 Nov 2025

The pylon-to-wing mount diagram, with the inset image showing details of the pylon aft mount connection to the wing clevis. (Source: Boeing, edited by NTSB)

The separated left pylon after recovery (left image) and the left pylon aft mount's fractured forward and aft lugs (right/enlarged image). Clear signs of fatigue (NSTB)

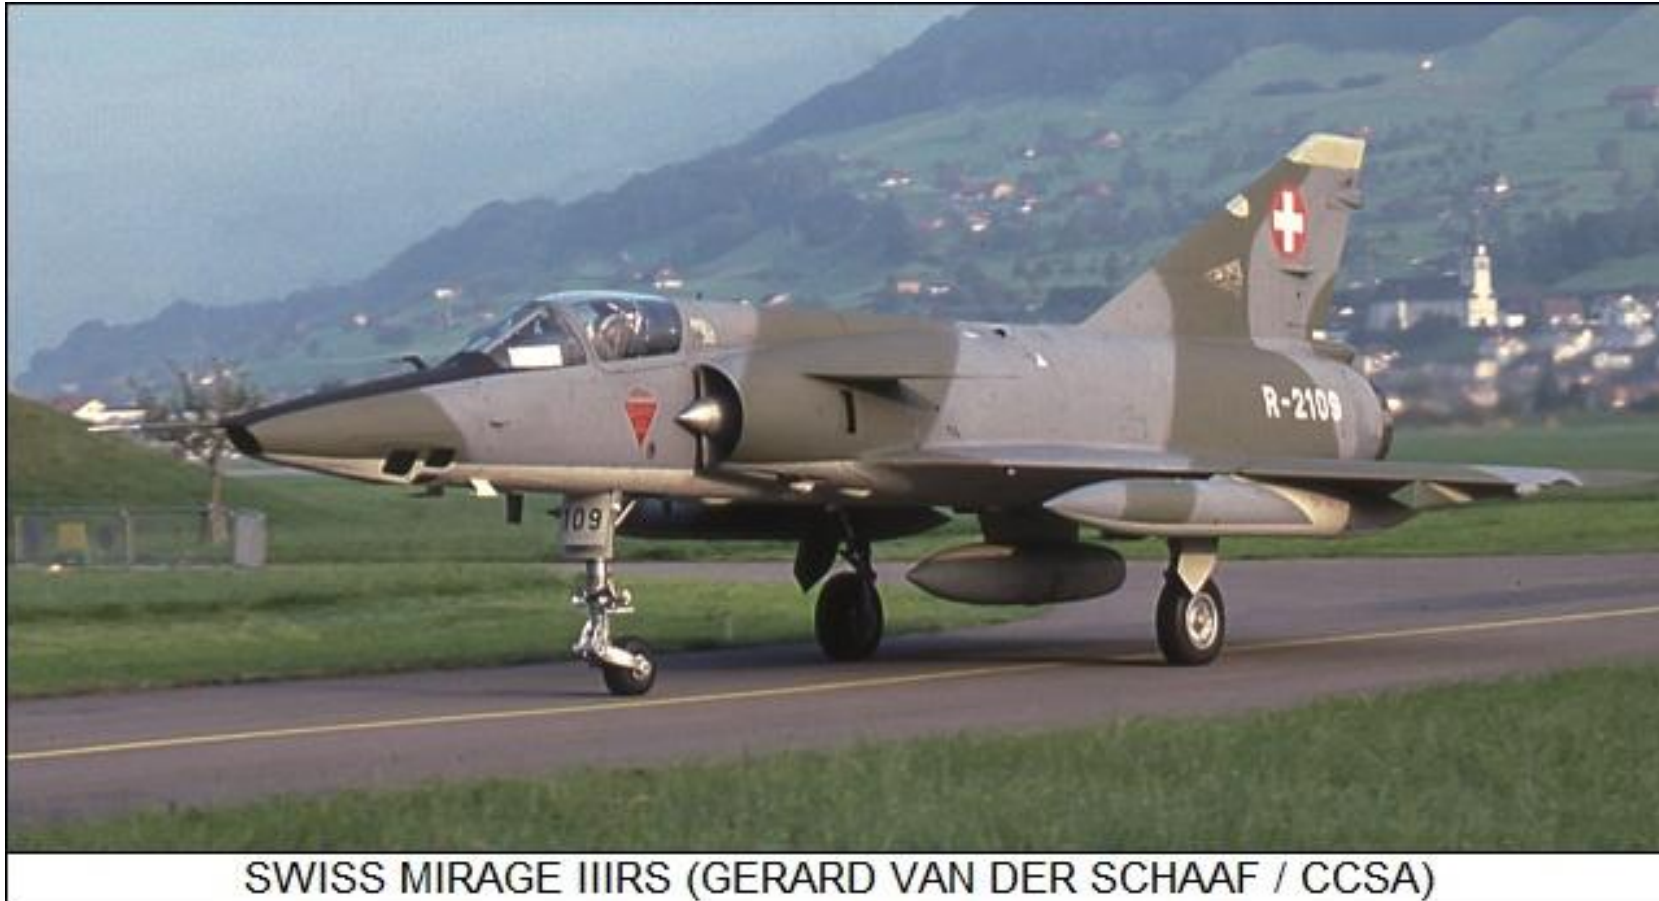
Mirage III Full-Scale Fatigue Test @ Emmen  
circa late 70s

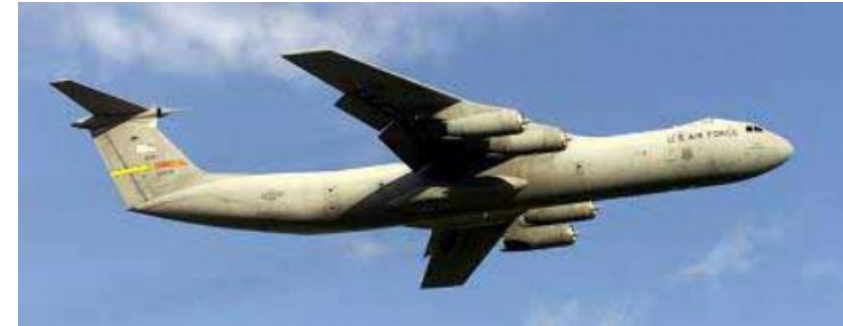
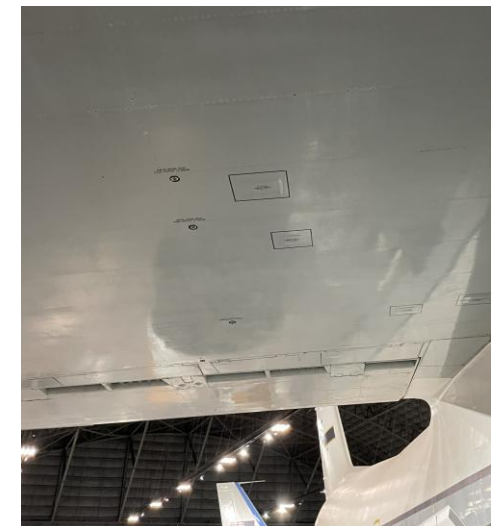
# C141 Wing Weep Hole Cracking Repairs (circa 1993)

- 120 aircraft repaired
- Usually 3 patches per repair
- 2300 bonded patches
- After 10 years – No problems (see Butkus [4])

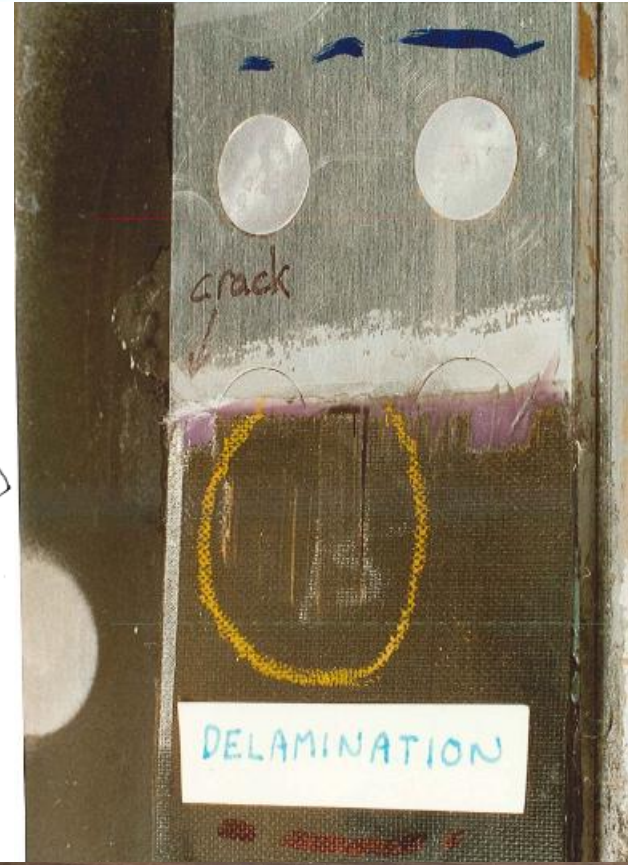
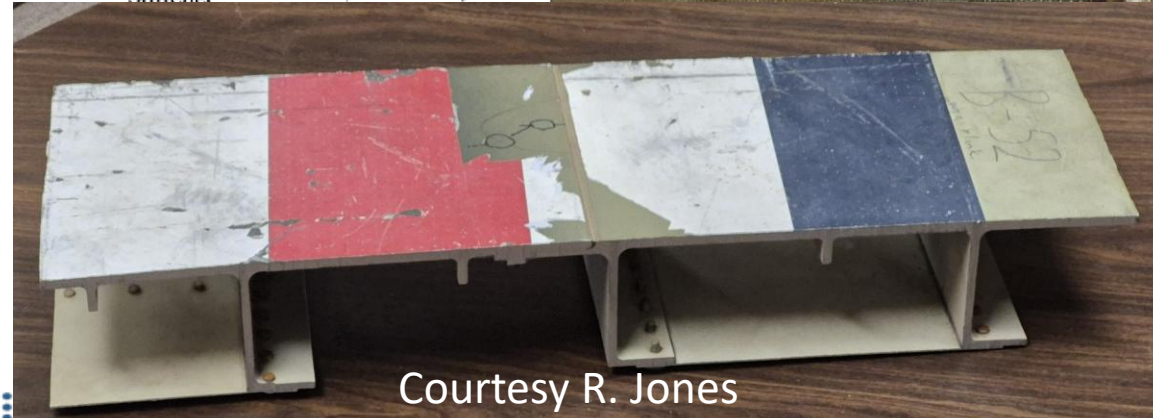
# B52 Wing Corrosion Repairs (circa 1994) [5]

Repair design and validation testing  
(Specimens with B52 wing Spec)

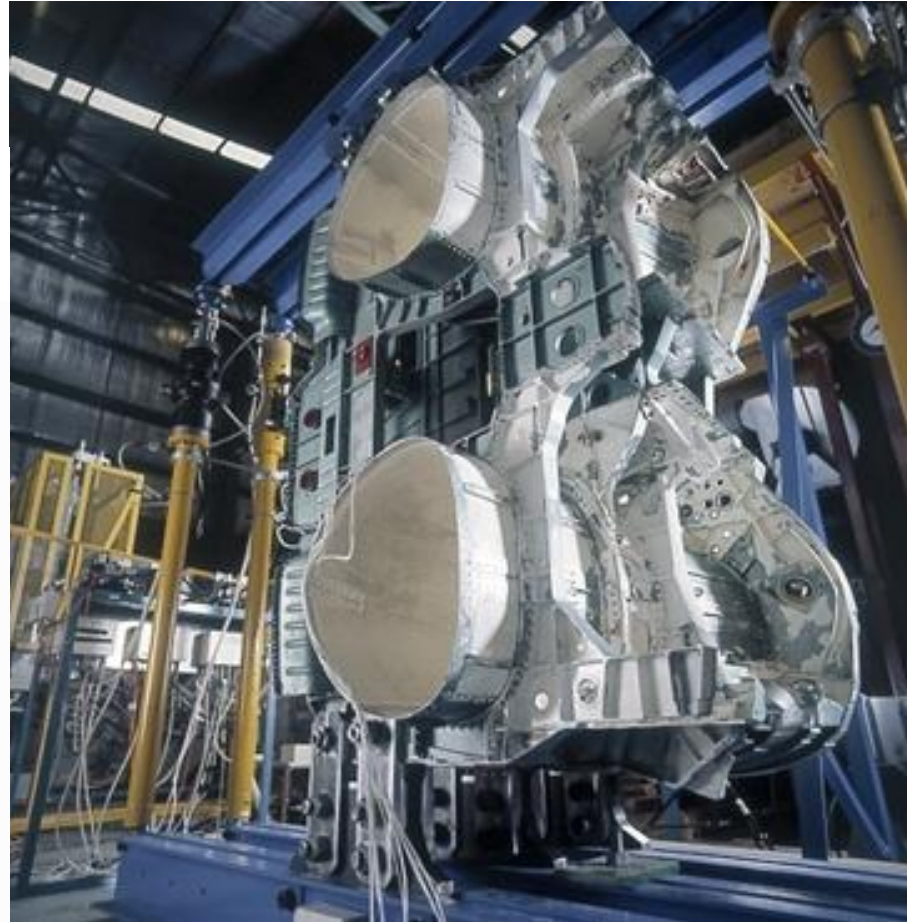
# Hornet “Centre Barrel” Test (High Speed Film)

- Fleet life extension of > 10%
- \$400M in real savings
- Delay purchase of JSF by 10 years

**Material:** 7050-T7451 Aluminium Alloy

**Weight:** ~ 500 kg (bare structure)

**Fracture Critical**

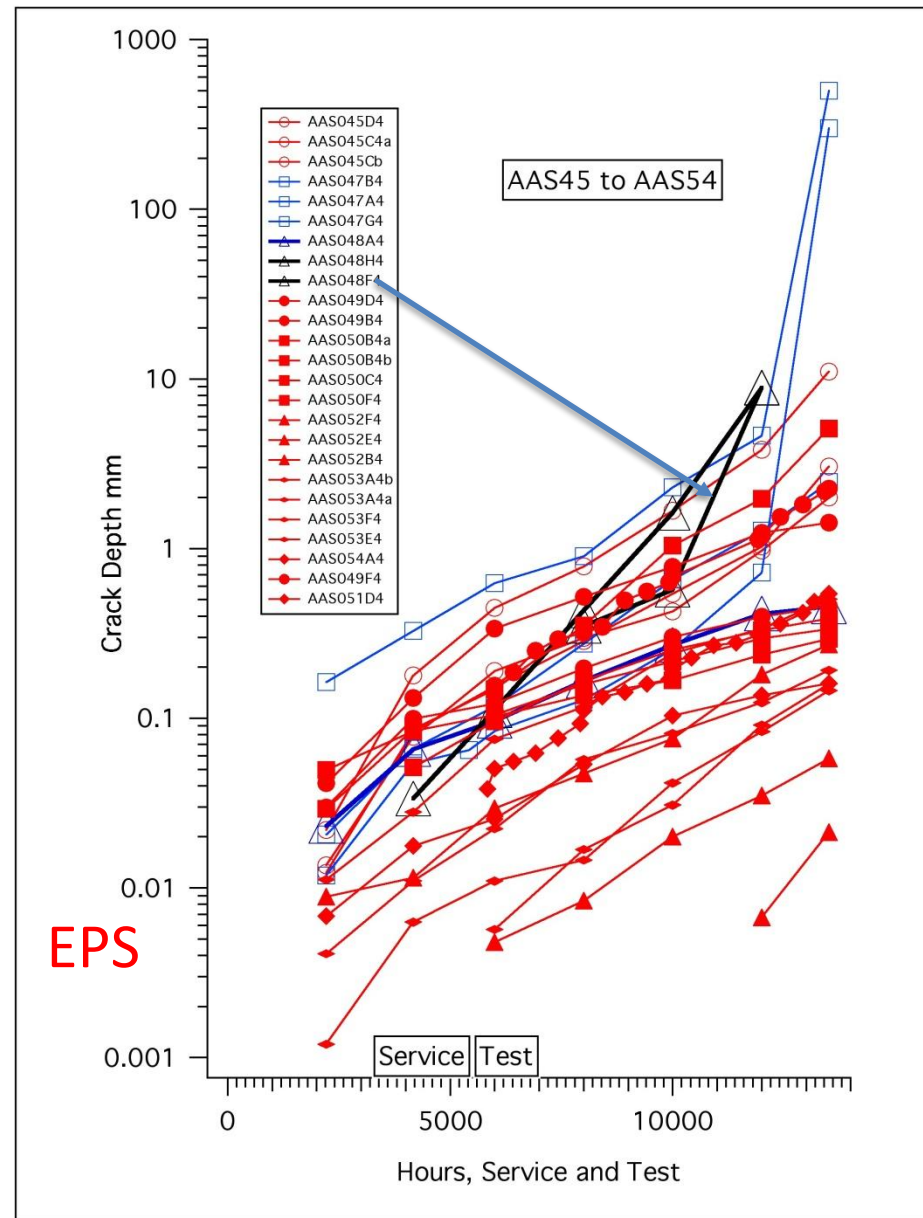
# Test Results from QF

- High confidence due to CPLT marker bands
- Appeared in-service **more** severe than test
- Data  $\approx$  Exponential
- Data used to life fleet wings; along with condition assessment

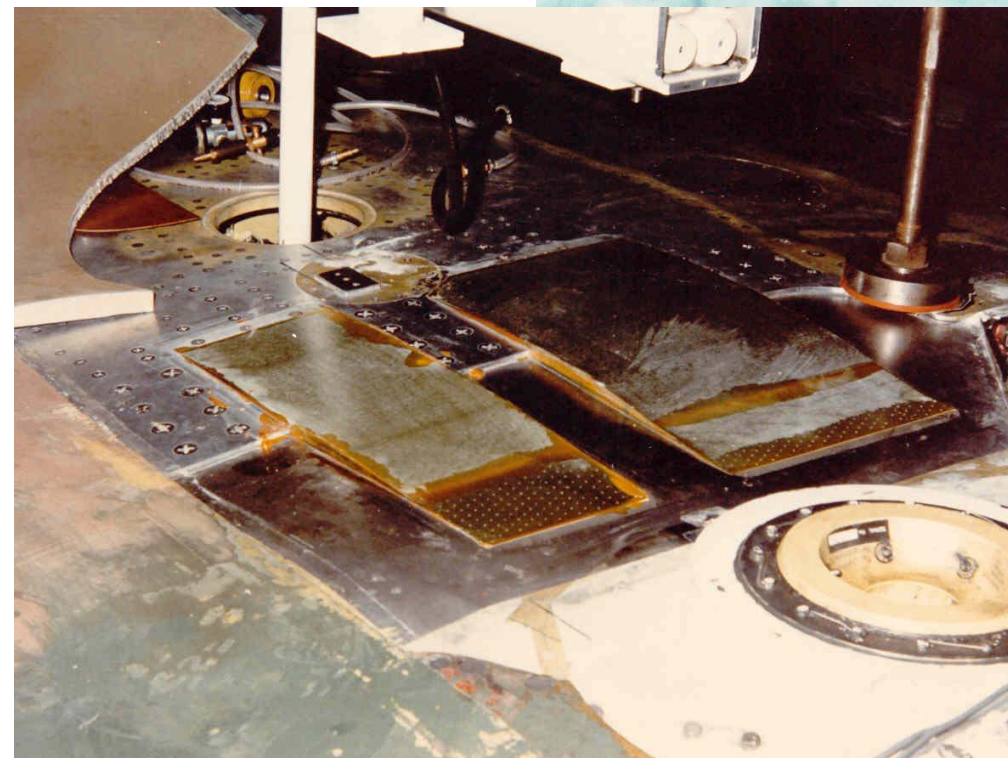
Boron/Epoxy Strengthening Doublers [14,16]

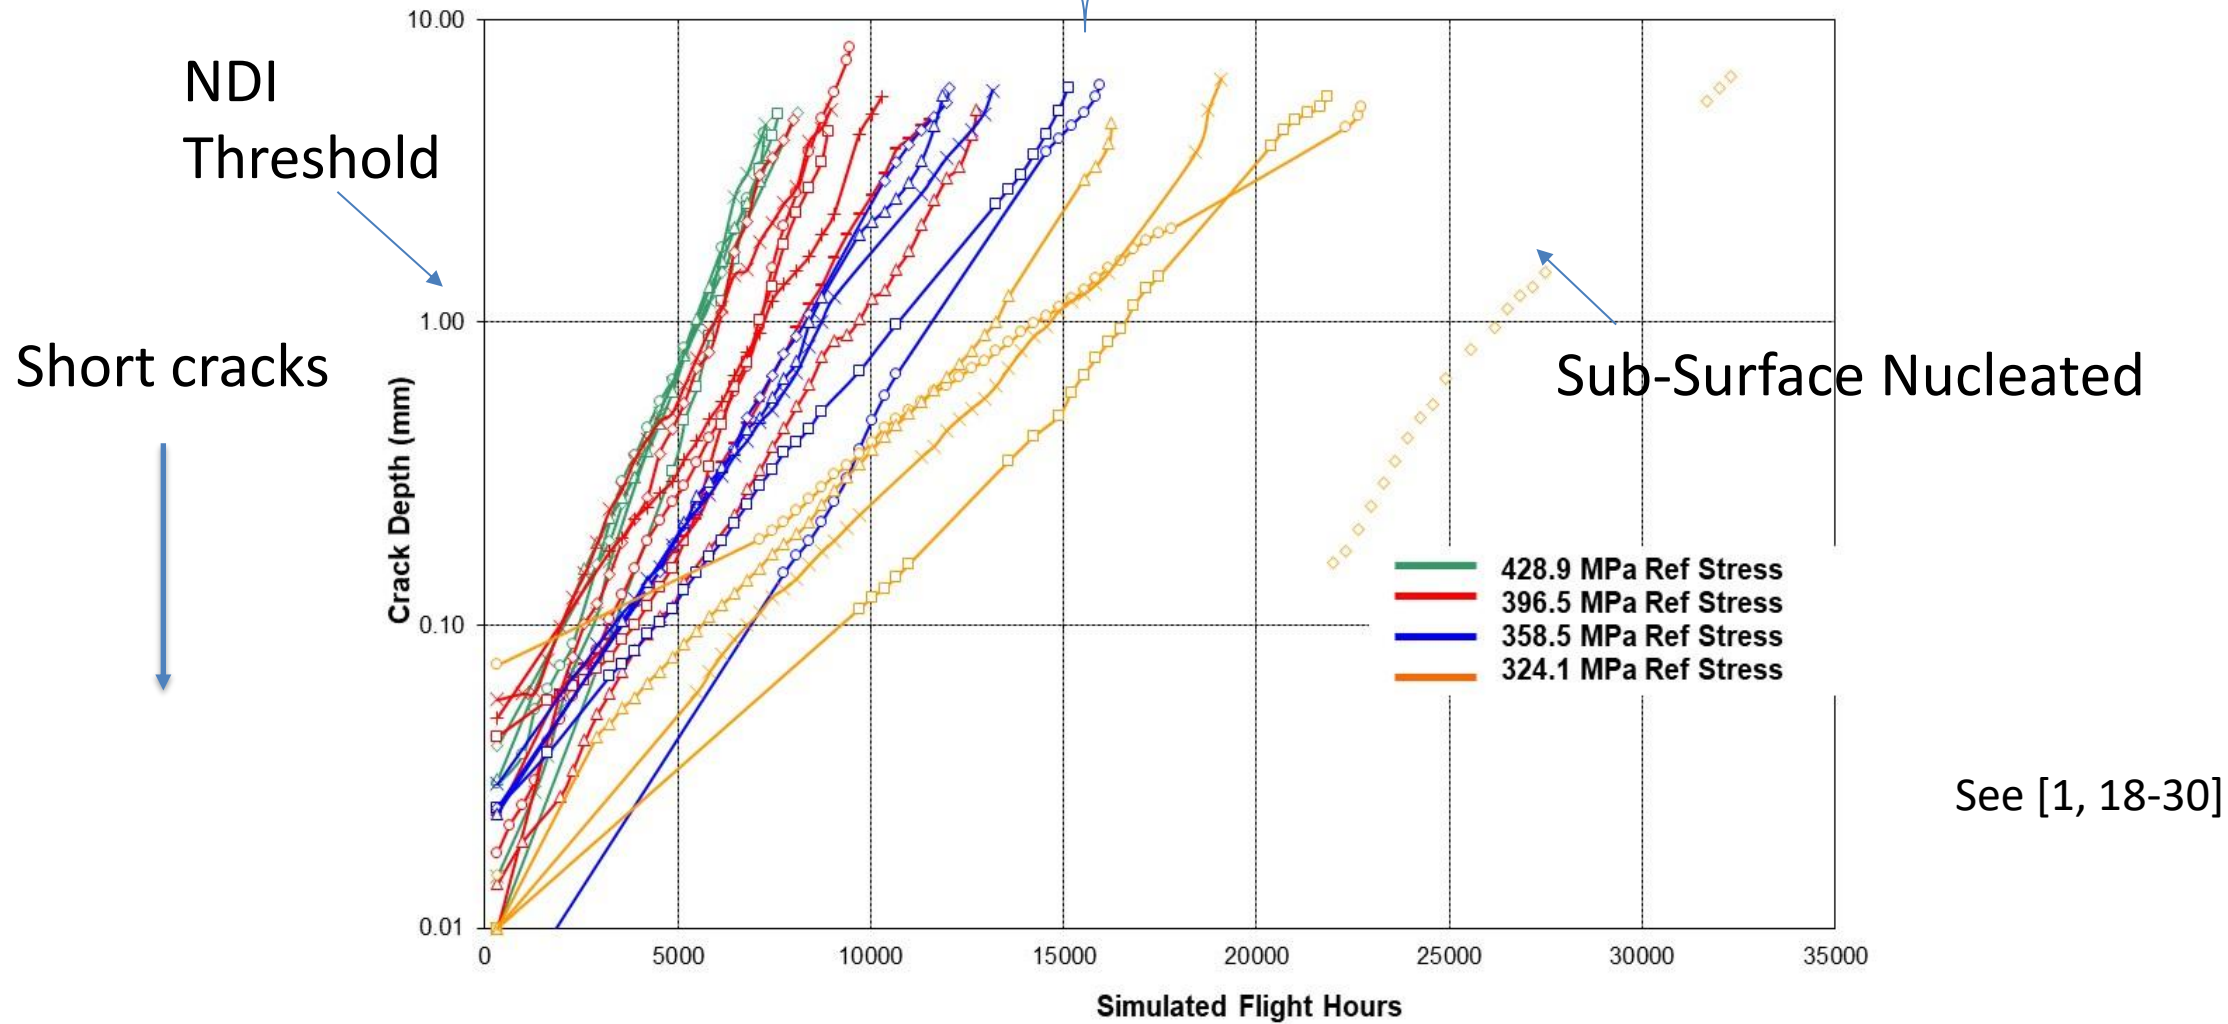
# Fatigue Coupon Crack Growth Results - Exponential

Near-Surface Nucleated

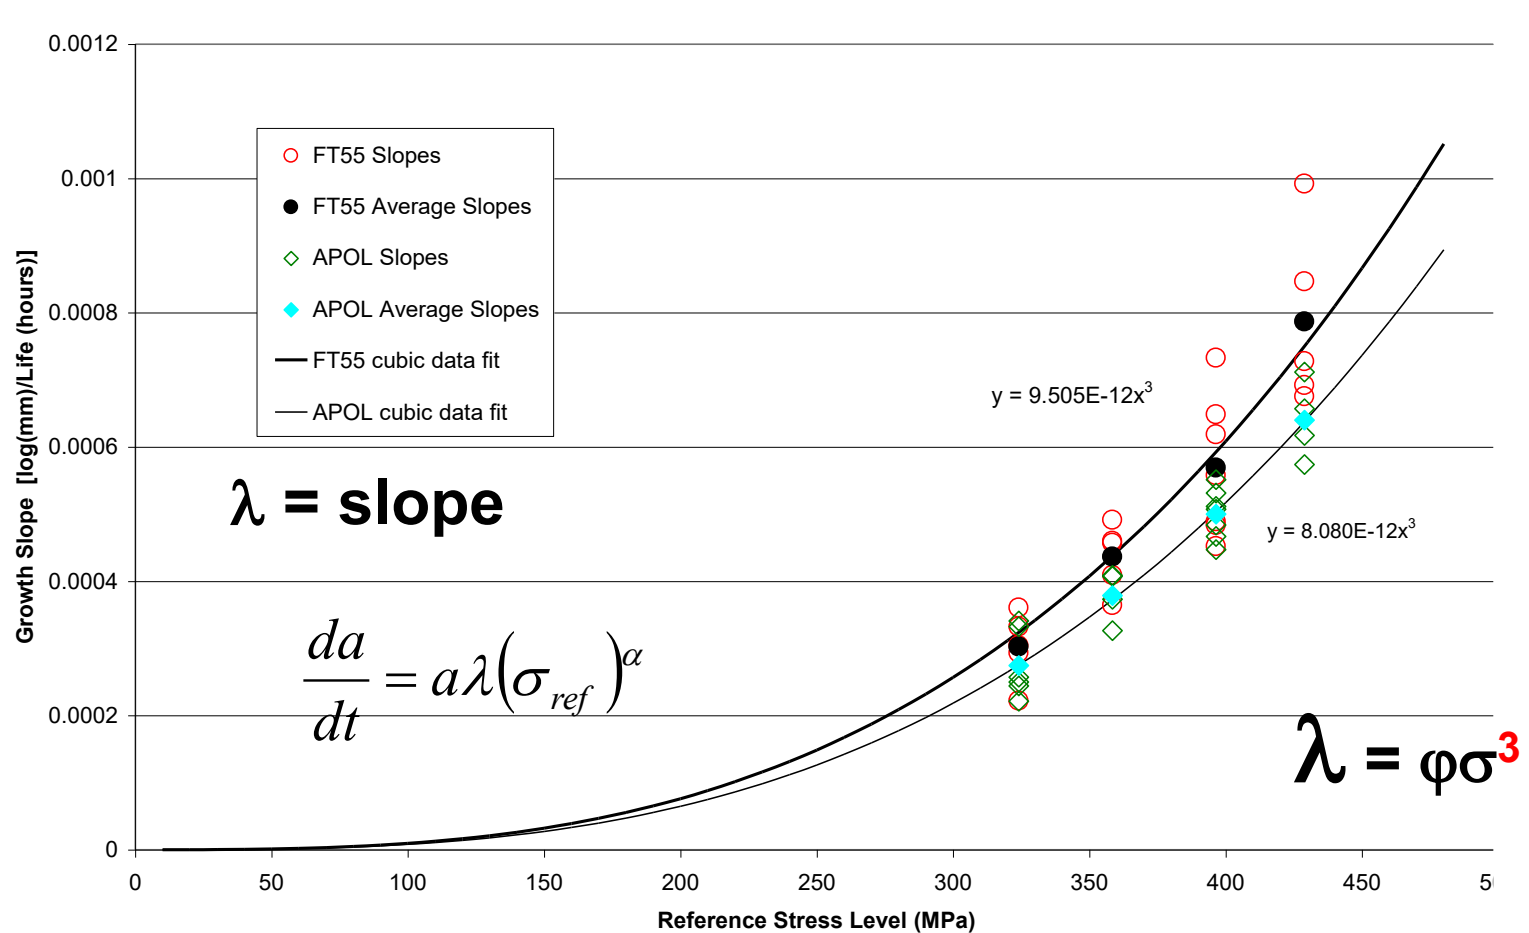
# Cubic Rule [29-31]

**Predict lives for same spectrum, material and Kt, at different stresses.**

From previous QF data.  
Best fit = Cubic

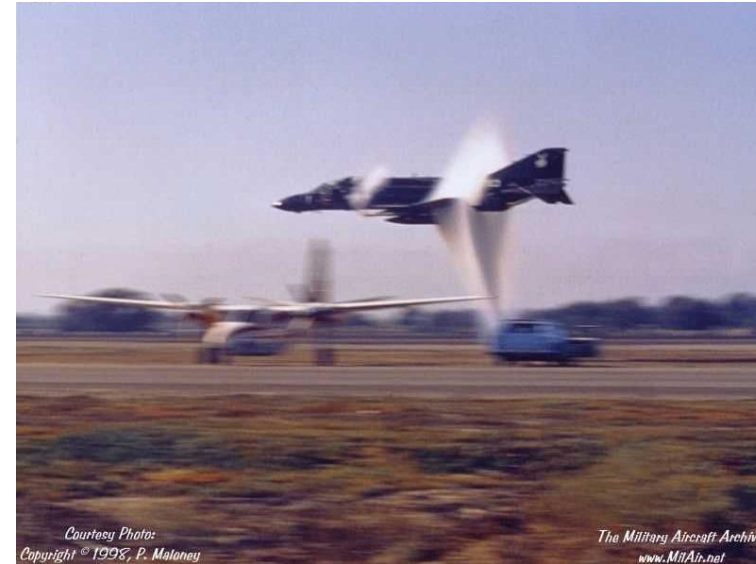
# Cubic Prediction – F-4 coupon test data

Used in RAAF Hornet, Pc9 and P3C etc structural repair manuals

$$a_2 = a_{0_2} e \left( \frac{\sigma_2}{\sigma_1} \right)^3 \lambda_1 N$$

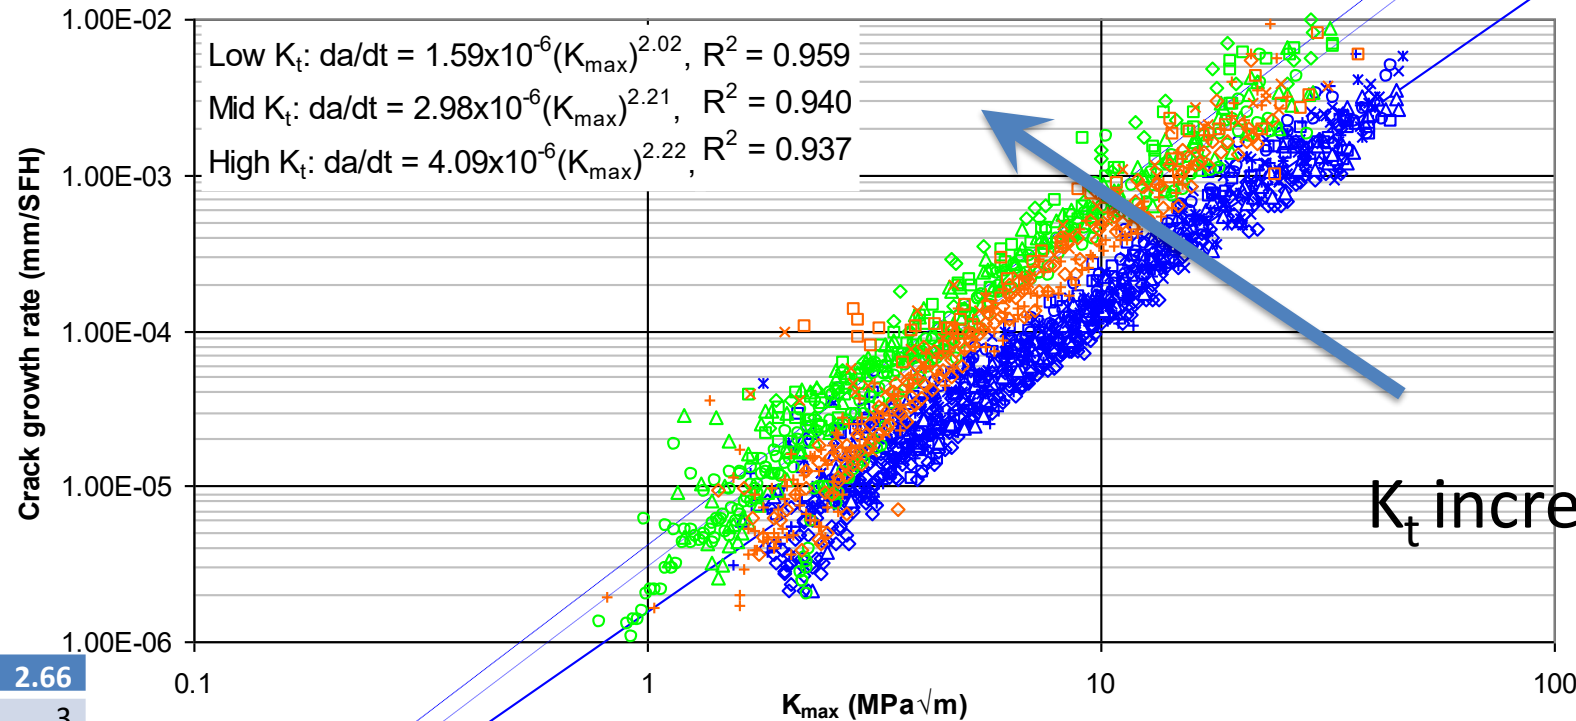
# Effective Block Approach [35-37]

Treat a Block of Variable Amplitude data like Constant Amplitude

Paris-Type Curve (all)

$K_t$  increasing

Net	1.04	2.1		2.66
Gross	1.04	2.15		3

Hornet spectrum, AA7050 at 3  $K_t$  values

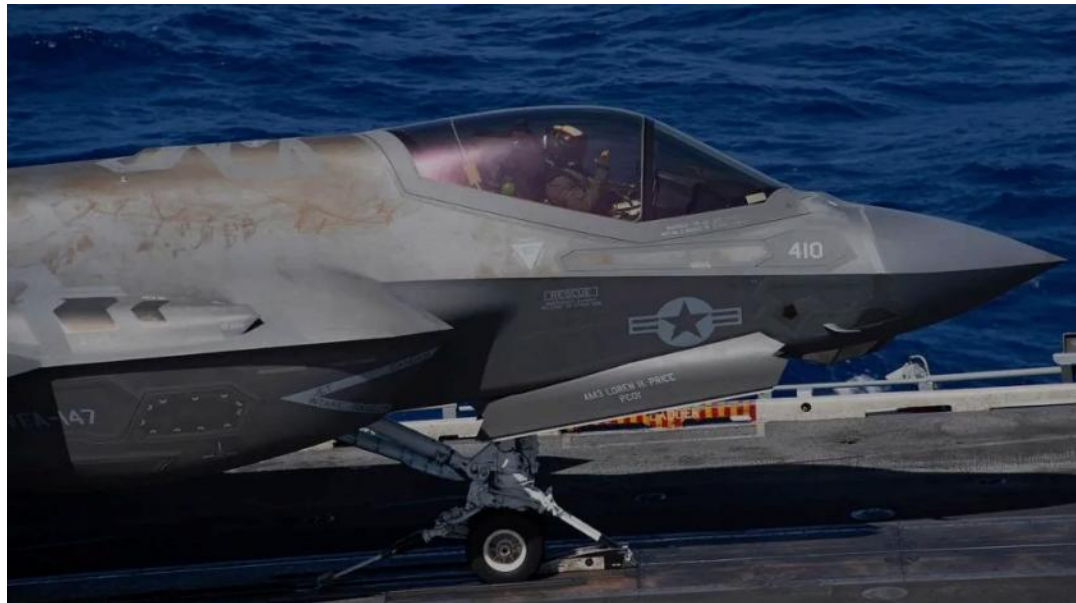
F35B on deck showing signs of corrosion causing discolouration – Source: *US Finds Solution to Corrosion Problem on F-35 Jets*, Aeronaut Media 13 Jul 25
